NASA TM-82393

## SEACOAST STRESS CORROSION CRACKING OF ALUMINUM ALLOYS

By T. S. Humphries and E. E. Nelson  
Materials and Processes Laboratory

January 1981

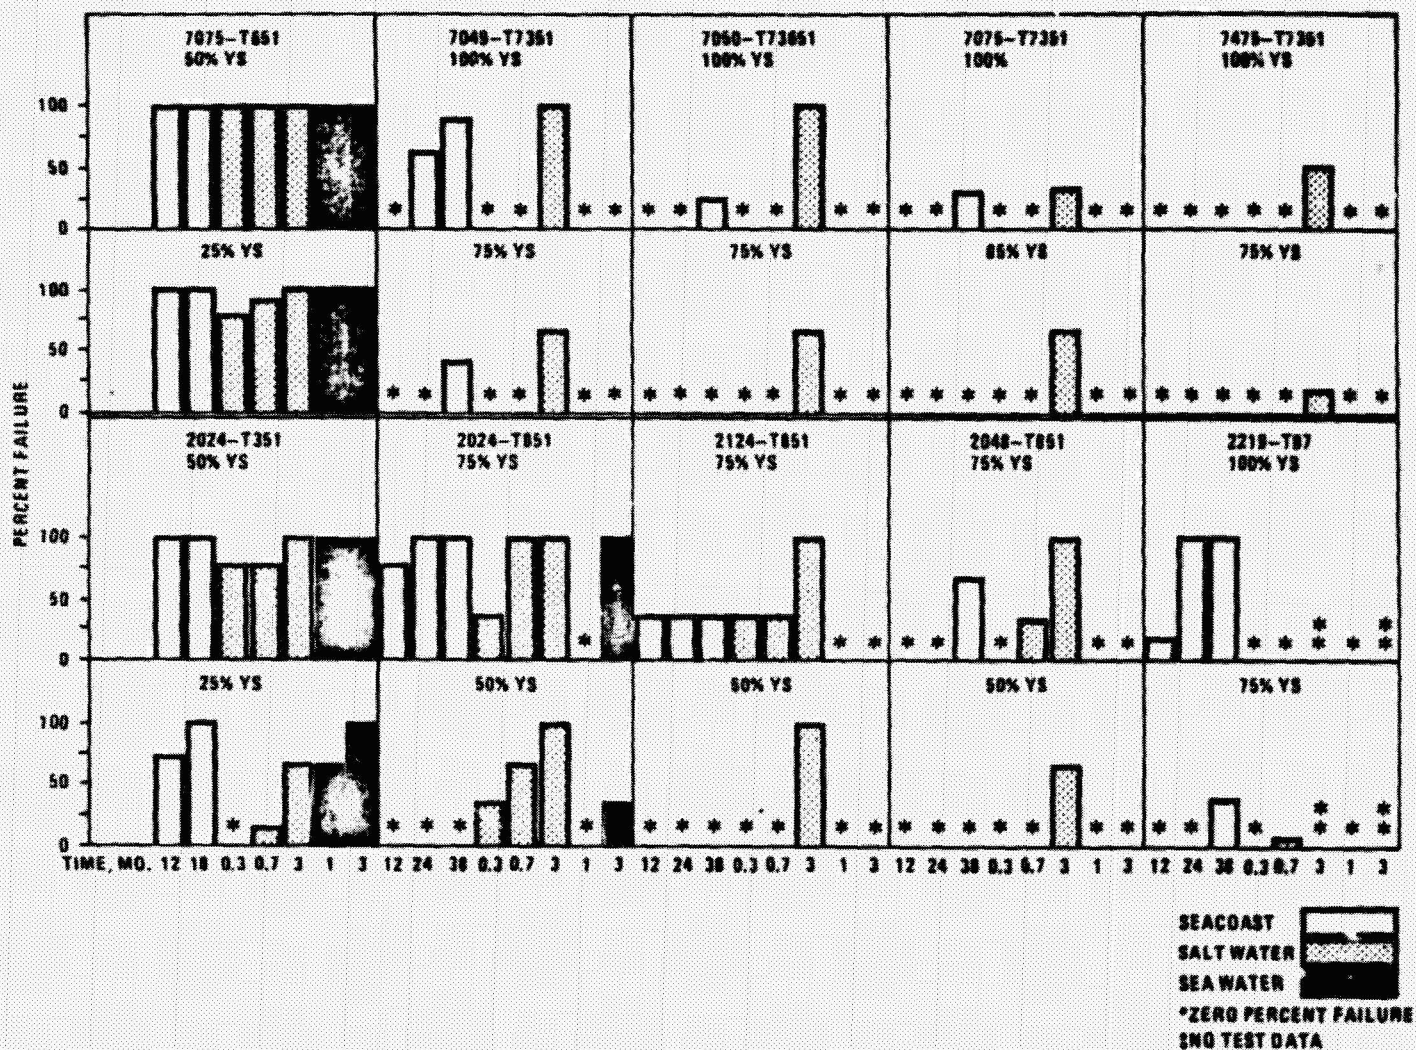
Figure 4. Comparison of SCC results based on selected exposure periods in several test media.

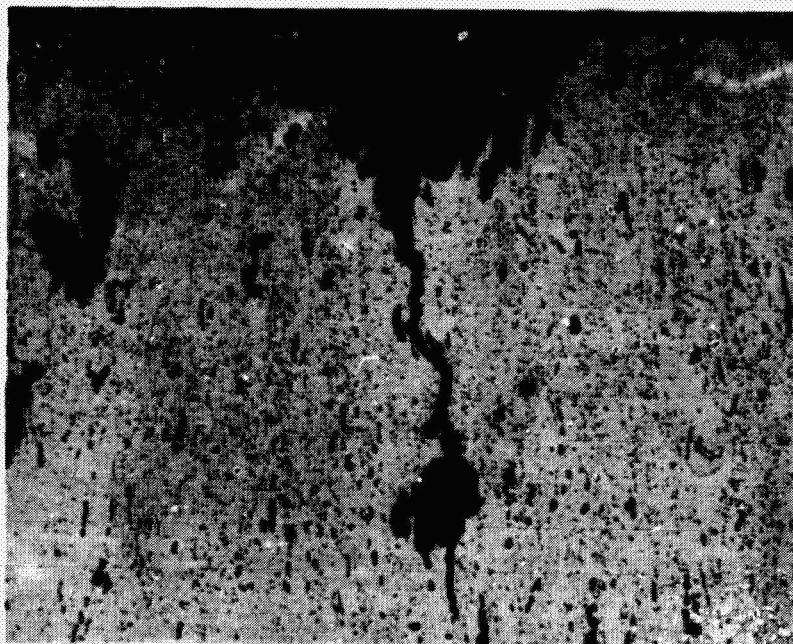
Figure 6. Photomicrographs showing the pitting and mixed mode cracking of 2219-T87 stressed to 100% Y.S. and exposed to KSC seacoast.

One year exposure was chosen for the seacoast at KSC to reduce the effect of pitting on SCC evaluation. A shorter exposure may be desirable because metallographic studies (both SEM and optical) failed to identify SCC as the major contributor to failure of the aluminum alloys with the exception of 2024-T351 and 7075-T651, although some failures occurred after only four months. Failure of the SCC resistant alloys (7049-T7351, 7050-T73651, 7075-T7351, and 7475-T7351) was reported by Kaiser [4] when highly stressed and exposed to the seacoast atmosphere at Daytona Beach, Florida for extended exposure periods. This agrees with the results obtained with these materials exposed to the seacoast at KSC. Kaiser did not present metallographic data to indicate the type and severity of corrosion of the failed specimens. Additional testing by the Aluminum Association, ASTM G1.06.91 Task Group is needed to ascertain the optimum exposure period for aluminum alloys in seacoast atmosphere and if, as believed, the optimum exposure period varies with location.
